NRL Memorandum Report 1383

# ABYSSAL CORROSION AND ITS MITIGATION

## PART II. RESULTS OF A PILOT TEST EXPOSURE

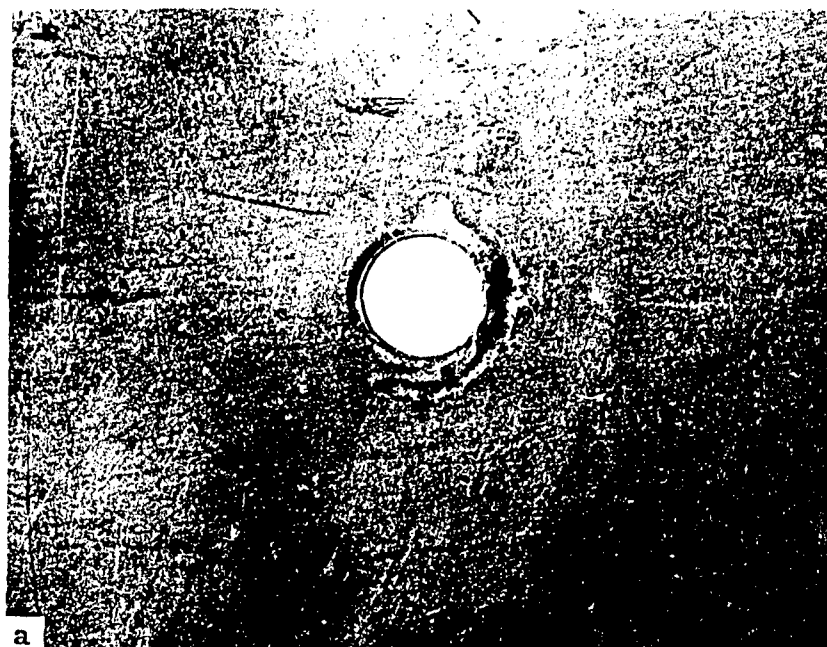
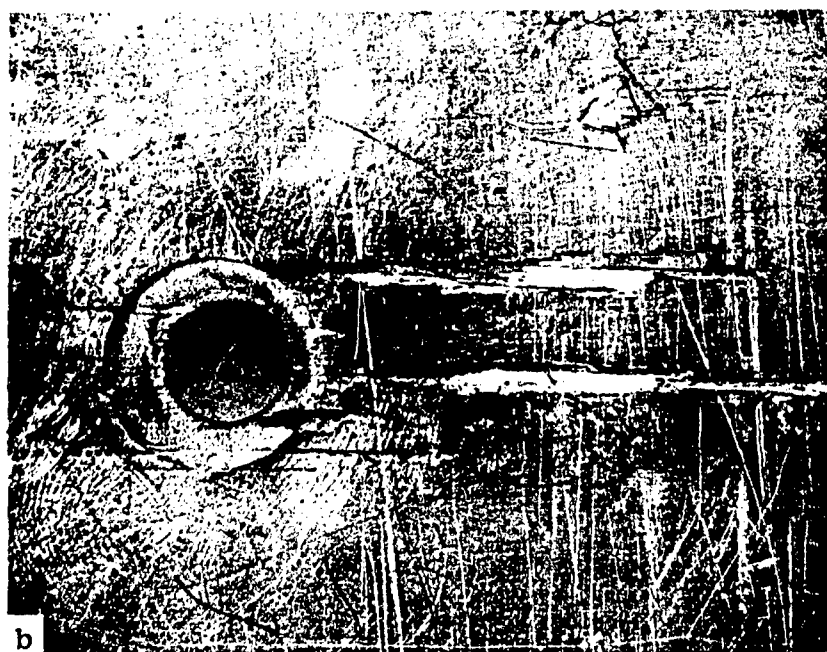
- (8) Proprietary alloy T\*\*\*, type 410 and type 430 stainless were corroded locally and had suffered perforation of the sheet when exposed at depth. Type 410 suffered much more severe crevice corrosion when exposed at depth as compared with the surface (Fig. 8).

Fig. 8 - Comparison of crevice corrosion of 410 stainless steel at (a) the surface, and (b) at 5700 feet
